URGENT FIELD SAFETY NOTICE

Product Name: **Alaris™ GS, GH, CC, TIVA, PK, Enteral Syringe Pump**

FSCA Identifier: **RA-2017-02-02**

Date: **March 2017**

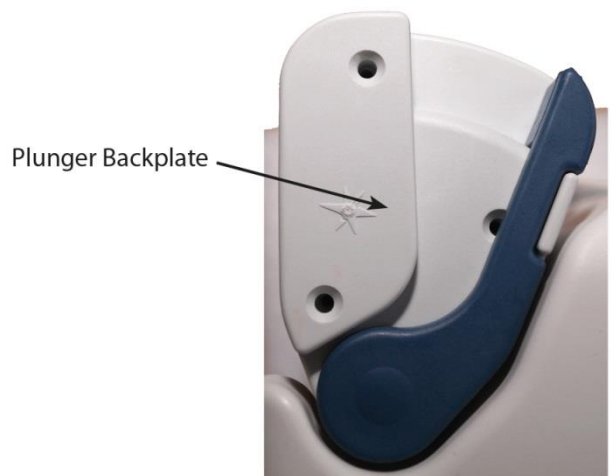
3. Remove three screws holding plunger backplate.

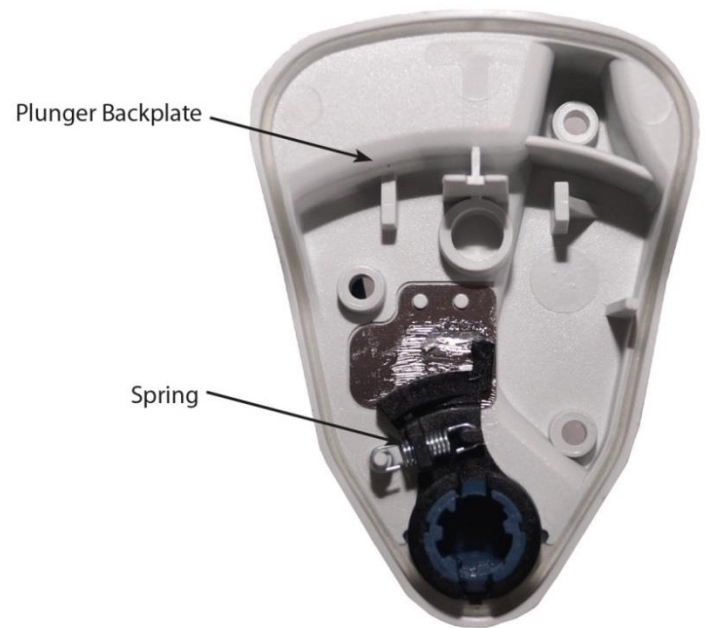
4. Remove the spring from the plunger backplate.
5. Fit a new spring to the plunger backplate.
6. Refit the plunger backplate.
7. Fit the three screws into the plunger backplate.

A kit of 10 replacement springs is available, part number 1000SP01589.
