Safety Advisory Notice

To all users of the
SIEMENS AXIOM Aristos FX

Re: AXIOM Aristos FX systems; possible drop of the cable holder

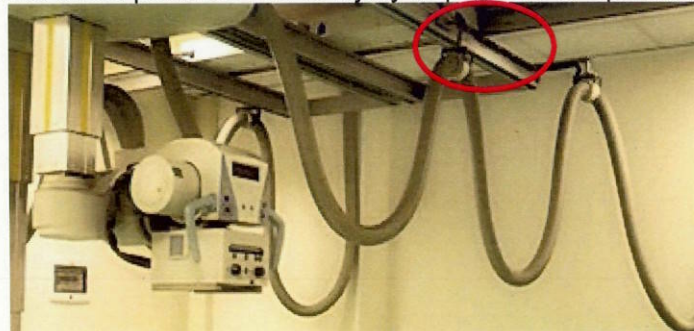
picture 1

In case, the 3 wheeled cable cart moves behind the point of the fixed cable holder, the corrugated hose may get stuck behind the hose from the fixed cable holder (picture 1).

In case the cable cart and the corrugated hose cannot move freely, the cable cart may get pushed out of the ceiling suspension if pulled into the direction of the tube stand. If this occurs, there is a potential for the cable holder to drop down and hit patients or system operators.

Please ensure, that the corrugated hose does not get caught behind the hose from the fixed cable holder and that it can move freely (picture 2).

- Siemens is preparing a field modification (UI XP091/14/S) for all AXIOM Aristos FX systems that will resolve this potential malfunction.

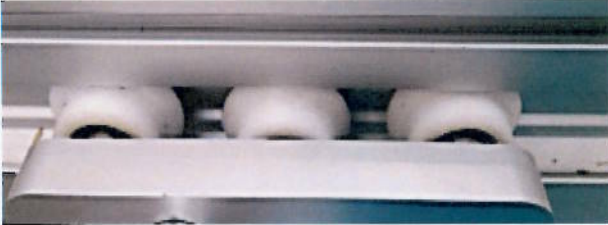
picture 3

Only the cable holders with 3 wheels are affected (picture 3). Cable holders with 4 wheels are not affected by this malfunction.
