### URGENT FIELD SAFETY NOTICE

Product Name: **Alaris™ GS, GH, CC, TIVA, PK, Enteral Syringe Pump**

FSCA Identifier: **RA-2017-02-02**

## Appendix 4 – Plunger Backplate Spring Replacement

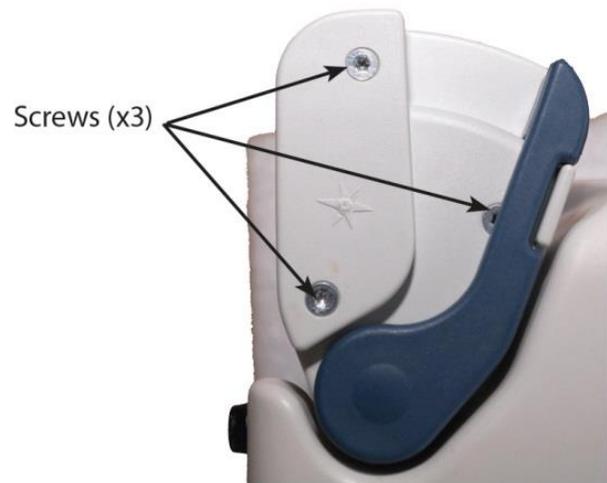
1. Remove the plunger backplate.

**Note:** Be cautious when removing as parts may become loose. Placing the Pump in a vertical orientation may assist with maintaining components in place.

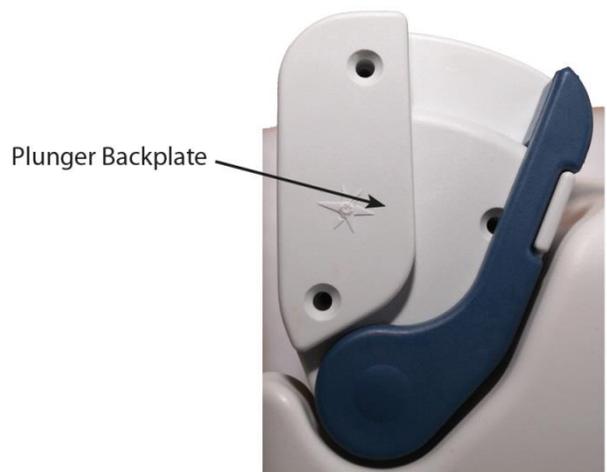
2. Visually inspect the interior of the plunger, replace any broken components.  
See Technical Service Manual *Chapter 6 Corrective Maintenance* for further details.

3. Remove three screws holding plunger backplate.

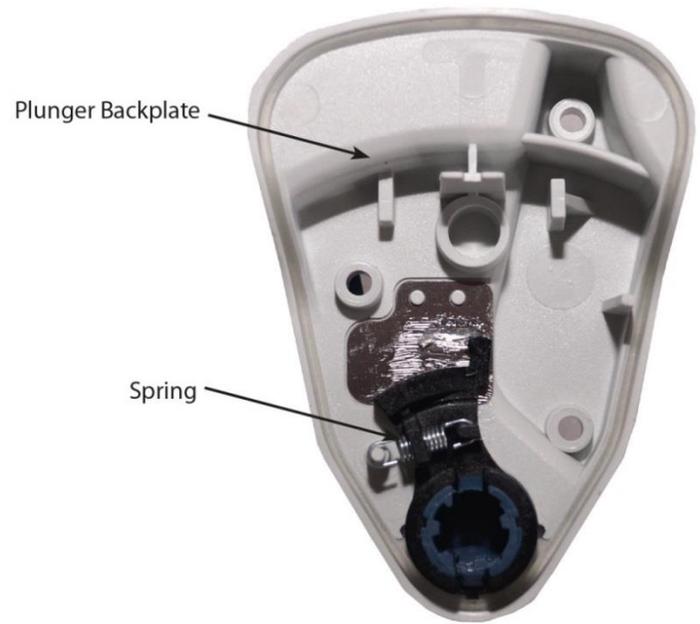
4. Remove the spring from the plunger backplate.
5. Fit a new spring to the plunger backplate.
6. Refit the plunger backplate.
7. Fit the three screws into the plunger backplate.

**A kit of 10 replacement springs is available, part number 1000SP01589.**
