URGENT - Field Safety Notice

Medical Device: MultiDiagnost-Eleva

Tilt actuator base unit

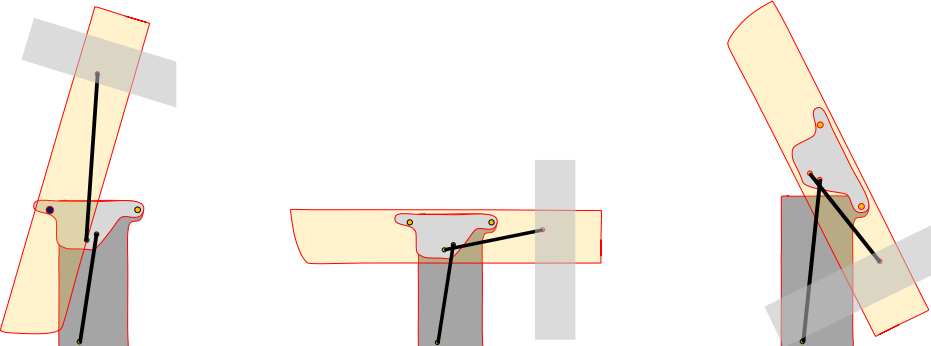
<p style="display: flex; justify-content: space-around;"> Tilt towards - 90° Table horizontal Tilt towards + 90° </p> </div>																
<p>HAZARD INVOLVED</p>	<p>If the fixation of the actuator breaks off and if the point of gravity of the table is beyond its rotation point, the table starts to rotate uncontrolled to its + / - 90 degree end point, which potentially could lead to the patient falling off the table.</p> <p>During procedures, the system is remotely operated from the control room. In case of an uncontrolled rotation, there is a risk of injury for the patient, user or bystander standing in the vicinity of the system (e.g. the tube may hit the legs of that person).</p> <p>This might lead to harm that necessitates medical intervention for the person involved.</p>

ACTIONS PLANNED BY PHILIPS	<p>All possibly affected products in the field will be corrected by means of a field change order free of charge.</p> <p>A Philips representative will replace affected material on the upper and lower tilt actuator in the affected systems.</p> <p>You will be contacted by our local Philips representative to schedule this corrective action.</p> <p>This action will start effective April 2018.</p>
FURTHER INFORMATION AND SUPPORT	<p>If you need any further information or support concerning this issue, please contact your local Philips representative: Technical Support Line: 1-800-722-9377, 8am to 8pm (EST) Monday thru Friday, or the UK Philips Customer Care Service Centre on 0870 532 9741.</p>
