URGENT Field Safety Notice

Trilogy Evo, Trilogy Evo O₂, Trilogy Evo Universal, Trilogy EV300
Environmental Contamination of Device Sensor

Philips Respironics Reference: 2023-CC-SRC-003

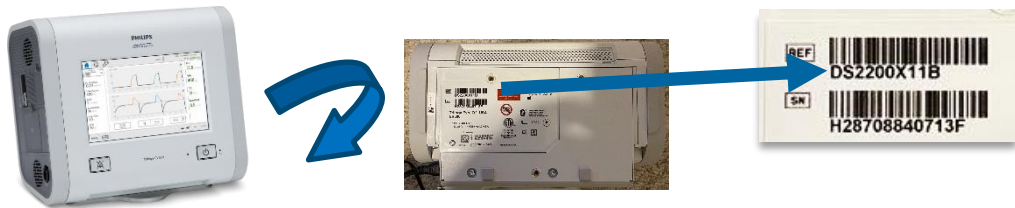
To identify the model, refer to the part number on the bottom of the device with the attached list of impacted part numbers:
