**FIELD SAFETY NOTICE**

**HEMOSIL PT-FIBRINOGEN HS PLUS, PART No. 0008469810,  
LOTS MANUFACTURED PRIOR TO JUNE 2014**

November 21, 2014

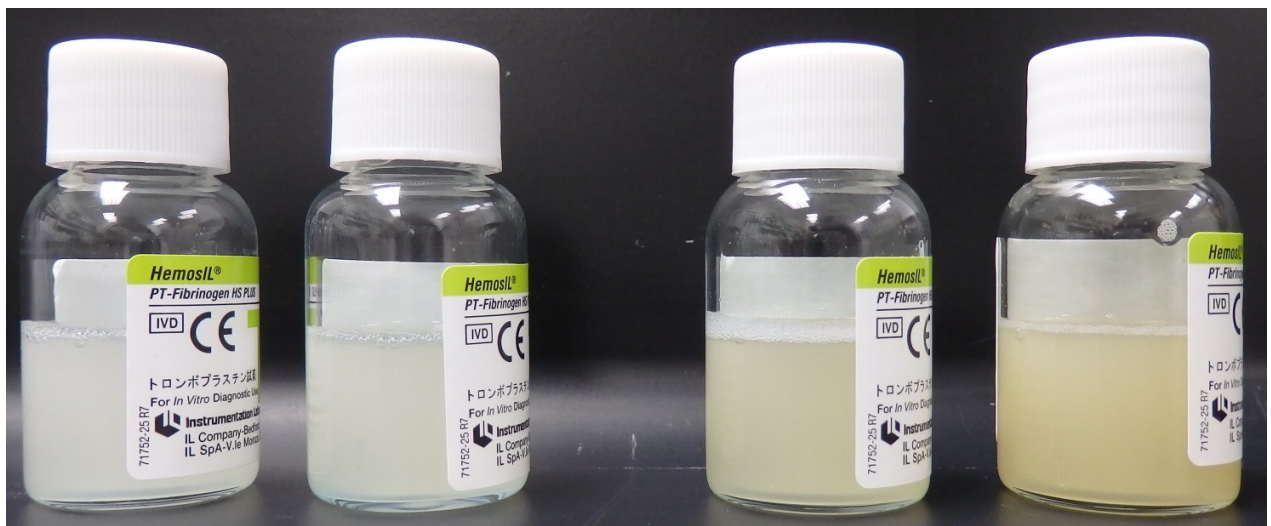
Specifically, some vials in these older lots exhibit a yellow / brownish color after reconstitution (yellow color or darker) instead of the typical white to off-white color. Vials exhibiting this yellow / brownish color were observed to cause prolonged prothrombin (PT) clotting times as discussed on the next page. Following is a list of in-date lots sold worldwide with the potential for affected vials:

This issue is attributed to higher levels of residual moisture in some vials, which contributes to the yellow/brownish color at reconstitution and the resultant prolonged PT clotting time results.

- Only use a vial if the reconstituted color is the typical white to off-white color.
- The picture below shows examples of unaffected and affected reconstituted vials:

**Unaffected Vials (White Color)**

**Affected Vials (Yellow Color)**

- If you observe any yellow / brownish color after reconstitution, **do not use the affected vial. Discard the vial and reconstitute another vial.**

**NOTE:** The yellow/brownish color is detectable after reconstitution, not with the lyophilized cakes.

CORRECTIVE ACTION TAKEN: Corrective action has been implemented starting with Lot N0640734 (June 2014) to prevent further occurrences of excess moisture in vials of HemosIL PT-Fibrinogen HS PLUS, PN 0008469810.
