FIELD SAFETY NOTICE

Object: **Field Safety Notice regarding the MoPyc Radial Head Prosthesis**

Ref/No.: **FA TOF-2016-035**

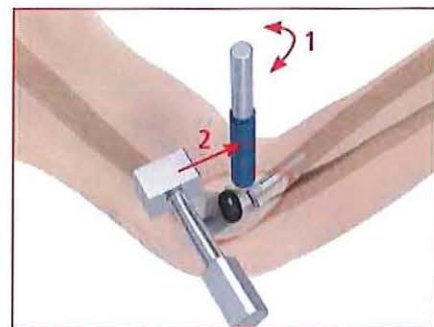
1. With the orientation tip correctly inclined, use it to impact the neck:

Seat the neck to the stem by applying a force distally while rocking the orientation tip a few degrees. A proper seating of the neck to the stem will make the patient's hand supinate and pronate when gently rocking the orientation tip. If rocking the orientation tip does not make the hand rotate, this means that the initial locking has not been completed. If so, perform this whole step again (no locking can be obtained by an inappropriate cleaned and dried surfaces).

2. Arm and forearm are firmly maintained by an assistant. With a hammer, give 2 to 3 series of 3 straight hits on the silicon part of the orientation tip.
3. Check the head is not disassembled from the neck. Vibrations generated by the neck / stem impactions may disassemble the head from the neck. Check the correct head / neck assembly applying a manual strength on the head. In case of head disassembly, remove the neck from the stem, take the head and the neck off, clean the surfaces

Impaction of the neck into the stem

with alcohol, re-assemble the neck with the head according to the technique described previously, and then impact again the neck into the stem.

Finally, in order to simplify the technique and to reduce the risk of misuse, we decided to develop a new impactor for guaranteeing the assembly between the neck and the stem.

By that time, we kindly remind to strictly follow the impaction steps of the neck into the stem as described in the current surgical technique to ensure strong assembly of the system.
