Field Safety Corrective Action for Class I Medical Devices

SpryStep Custom AFO, SpryStep Vector AFO, and SpryStep Vector KAFO

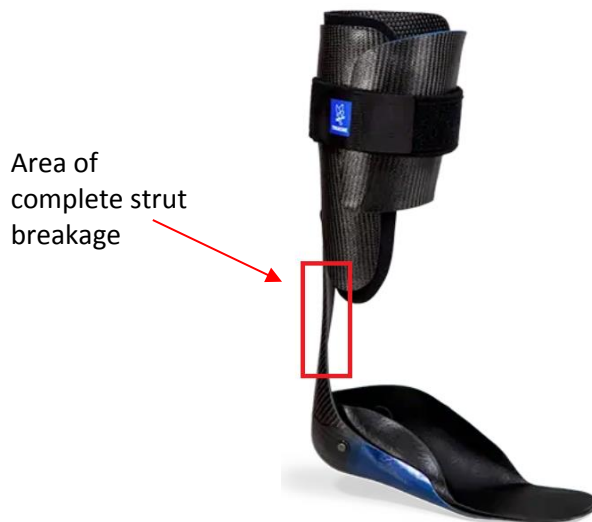
The reason for the corrective action is due to a complete strut breakage, as shown in the picture below. We received reports of a small number of braces with a complete strut breakage either upon examination by clinician at initial receipt, during patient application, or shortly thereafter.

Due to a vacuum system leak, there is the possibility that air pockets exist between the layers of material that may cause the strut to completely break or fracture, resulting in a potential loss of balance and/or potential of a fall.

The device failure is due to possible air pockets in the strut, resulting in breakage. This might be observed at initial receipt, during patient application, or shortly thereafter.

- During the patient visit, the clinician / CPO should examine the device for structural defects (delamination, cracking, complete breakage, etc.) in the area identified in the picture above in Section 3.

- Eliminated leaks in vacuum system.
- Conducted 100% inspection of finished products.

- Verify and document the vacuum system is continuing to function properly by conducting a daily drop-test.
- Continue conducting the 100% inspection of finished products.
