## **Urgent Field Safety Notice**

### Sterile Percutaneous Reference Pin (Model #9733235 and 9733236)

Percutaneous Pin Cross-Pin Fit Issue
Recall

Medtronic Reference: FA1384

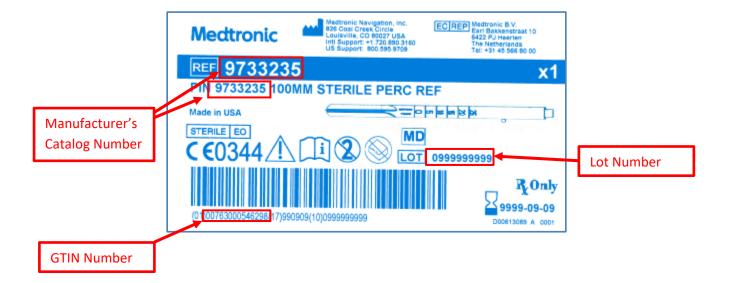
Medtronic has become aware that certain percutaneous pin lots (see Table 1) have been identified as having a cross-pin that may render the percutaneous pin unable to fit into the Tap Cap, or too tight to remove the Tap Cap from the percutaneous pin once placed in the pelvis. This issue is associated with recently manufactured lots of the Percutaneous Pin used during spinal surgeries.

Figure 1. Percutaneous Pin Cross pin identification (left) and fit issue with Tap Cap (right)

- 1. Immediately locate and quarantine all unused impacted product(s). Refer to the affected lot numbers identified in Table 1 below.
- 2. Return the impacted product(s) to Medtronic.
- 3. Complete the Customer Acknowledgement Form enclosed with this letter, acknowledging that you have received this information.
  - If the affected devices have already been utilized and/or discarded, we still ask that you complete and return the Customer Confirmation Form detailing that information.
- 4. This notice should be distributed to all others in your organization who should be aware, or to any organization where the potentially affected devices have been transferred. Please maintain a copy of this notice in your records.
