FSN Ref: MC333 FSN

FSCA Ref: MC333 FSCA

Urgent Field Safety Notice (FSN)
Device Commercial Name
Risk addressed by FSN

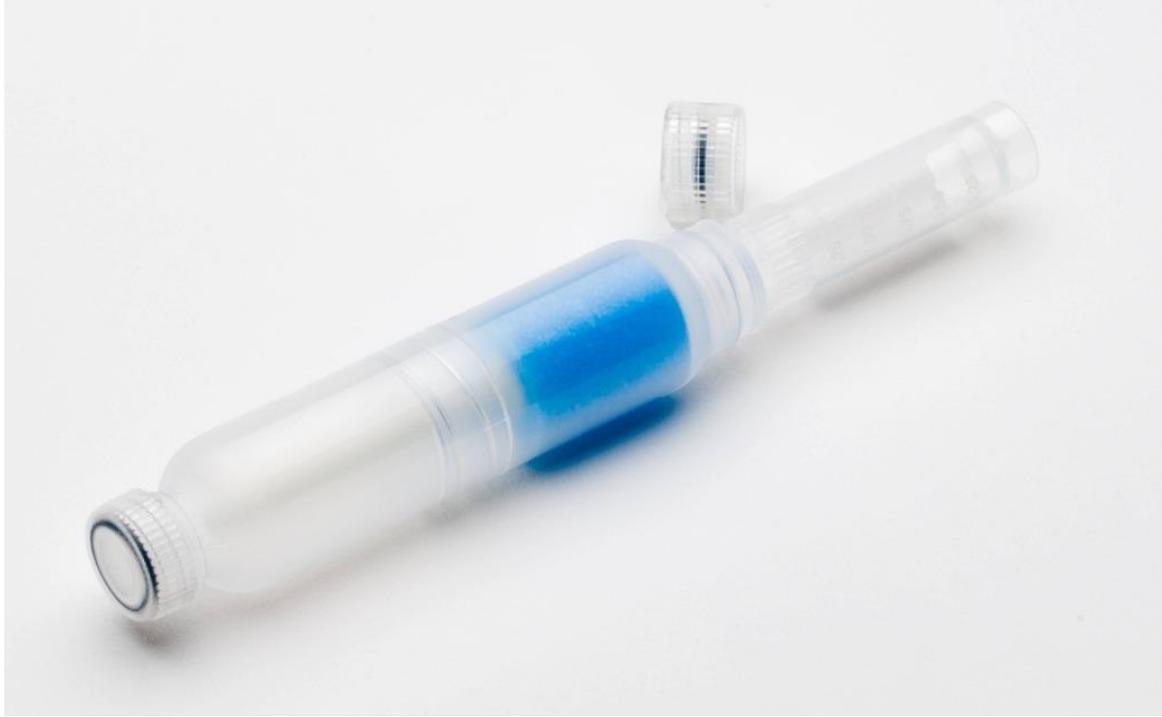
1. Information on Affected Devices*	
1.	<p>1. Device Type(s)*</p> <p>The device affected by this FSN is the S14 Oracol+ saliva collection device. Photo is shown below to clearly show which device is affected.</p> <p>S14 Oracol+</p>

2.	<p>1. Description of the product problem*</p> <p>The S14 device has been demonstrated by in house and customer testing to leak sample during the centrifugation process that extracts sample from the swab. The leak is occurring at the join between the microtube and the main body where the sample is escaping through the screw fit connection. The devices are only leaking a small amount of saliva sample approx. 50µl when the average sample collected in the microtube is between 250 - 800µl.</p>

3.	1. Action To Be Taken by the User*	
	<input type="checkbox"/> Identify Device <input type="checkbox"/> Quarantine Device <input type="checkbox"/> Return Device <input checked="" type="checkbox"/> Destroy Device <input type="checkbox"/> On-site device modification/inspection <input type="checkbox"/> Follow patient management recommendations <input type="checkbox"/> Take note of amendment/reinforcement of Instructions For Use (IFU) <input type="checkbox"/> Other <input type="checkbox"/> None <p style="color: red; font-weight: bold;">Please destroy any remaining stock of S14 Oracol+ devices that you have.</p>

3.	2. By when should the action be completed?	25/02/2022
3.	3. Is customer Reply Required? * (If yes, form attached specifying deadline for return)	No
3.	4. Action Being Taken by the Manufacturer	
	<input checked="" type="checkbox"/> Product Removal <input type="checkbox"/> On-site device modification/inspection <input type="checkbox"/> Software upgrade <input type="checkbox"/> IFU or labelling change <input type="checkbox"/> Other <input type="checkbox"/> None <p style="color: red; font-weight: bold;">The S14 device will be removed from sale. Until the design of the device is altered to prevent sample leakage from the device.</p>	
3	5. By when should the action be completed?	04/02/2022
