July 13, 2016

Subject: **URGENT FIELD SAFETY NOTICE - CORRECTION**

Zimmer Biomet Surgical is initiating a Medical Device Correction (followed by a phased removal) for all serial numbers of the Zimmer Air Dermatome II Handpieces and all lot numbers of the Zimmer Air Dermatome II Width Plates distributed between March 2012 and August 2015 (including loaner devices).

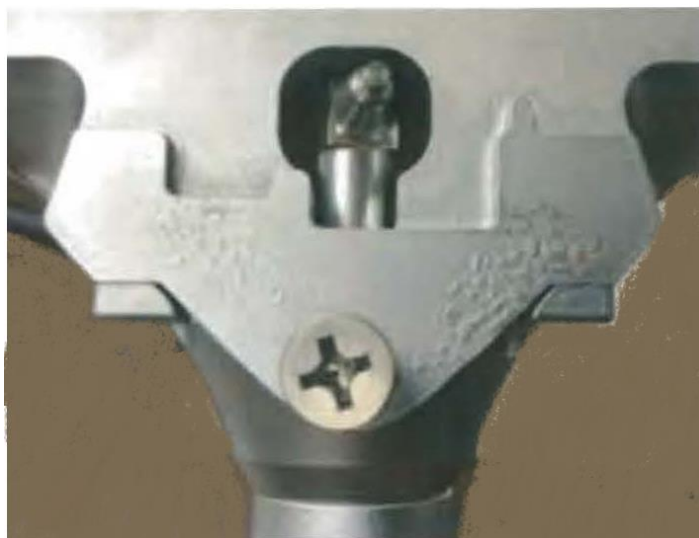
Zimmer Biomet Surgical has received product complaints reporting that the surface coating applied to the device is blistering, peeling and discoloring after usage over time (see Image 1). There have been no injuries associated with the reported complaints. In addition, an independent assessment determined that the blistering, peeling and potentially flaking of the surface coating is not expected to result in any long range health consequences. Given that the frequency of this surface coating condition can worsen with age, Zimmer Biomet Surgical is currently making preparations for replacement activities to follow in order to prevent future complaints. This document is provided to alert all users of the potential for the surface coating to exhibit blistering, peeling, and discoloring after usage over time. A separate recall removal notice will be issued to facilities, in phases, with detailed instructions in August 2016. **Your sales representatives will be notified when a replacement is ready. Do not return product at this time as part of this action.**

Image 1. Blistering on Zimmer Air Dermatome II

1. Please carefully review this letter and ensure all users of the Zimmer Air Dermatome II at your facility have been informed of this notice.
2. Inspect the Zimmer Air Dermatome II devices within your facility and indicate on the attached Certificate of Acknowledgment the condition of the device. Please complete and sign the attached Certificate of Acknowledgment and return it to Fieldaction.Emea@zimmerbiomet.com.
3. Before each use, continue to examine the surface coating for blistering/peeling.

- a. If the blistering/peeling characteristics are not present, you may continue to use. Immediately after each use, re-examine the surface coating for blistering/peeling.

- b. If the blistering/peeling characteristics are present, discontinue use. In the event that alternate devices or therapies are not available, surgeons may, at their discretion, determine the use of the device as a medical necessity and continue to use. After use, follow your facility's wound irrigation protocol or Zimmer Biomet recommends copious irrigation with a normal saline solution or immersion of the graft in a bowl of normal saline. Zimmer Biomet recommends irrigating the donor site with saline as well. Carefully examine the skin graft and donor site for gray coating flakes and continue to irrigate as necessary. Please report this as an adverse event to Zimmer Biomet Surgical at winterthur.per@zimmerbiomet.com.
