## Urgent Field Safety Notice

### Instruction for Use update for aView 2 Advance

**Ambu A/S - Single Registration (SRN): DK-MF-000001437**

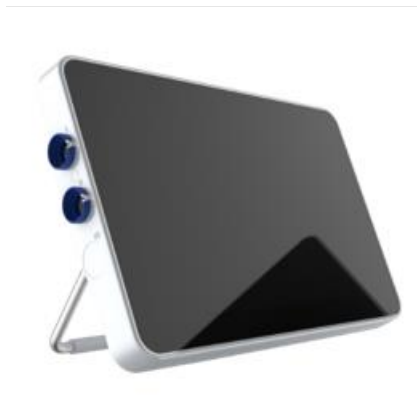
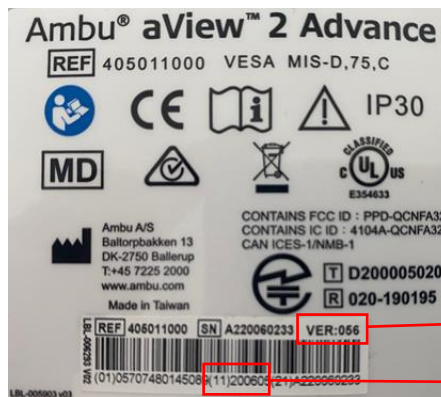
Version no.: **VER:0XX**

Manufacturing date: **(11)YYMMDD**

You should check the version number and manufacturing date (as indicated above) of your device to identify if you have a potentially affected device within your facility. In the case that your device is related to the earliest configurations of Ambu® aView™ 2 Advance, you address this by familiarizing yourself with the information in the Instruction for Use insert and keep the insert together with the Instruction for Use.
