URGENT - Field Safety Notification Medical Device Correction

Philips HeartStart MRx Monitor/Defibrillator on exceptionally rare occasions may exhibit abnormal behavior when operating using a single battery as the sole source of power.

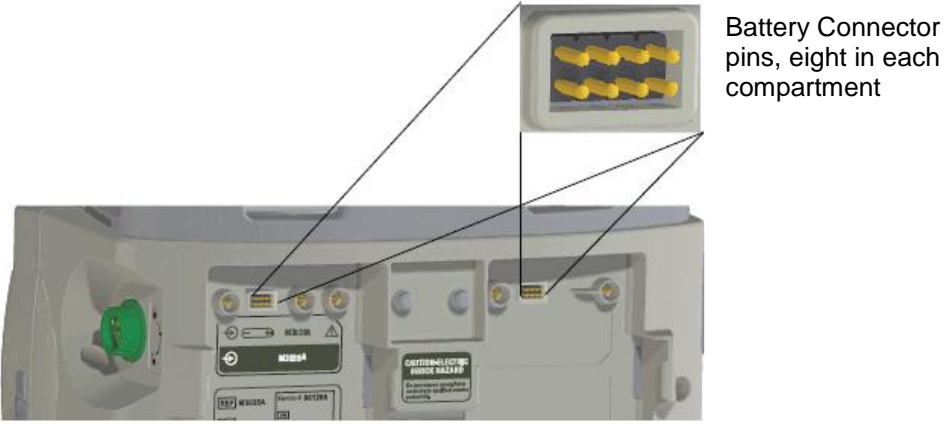
<p>BEHAVIOR DESCRIPTION 1</p>	<p>If the battery connecting pins (in the battery compartment of the HeartStart MRx Monitor/Defibrillator) become damaged or contaminated, it could result in a poor electrical connection that may cause the MRx to either (i) not power on or (ii) repetitively reboot, when used on battery power only.</p>
<p>HAZARD INVOLVED 1</p>	<p>HeartStart MRx Monitor/Defibrillator may, on exceptionally rare occasions, either (i) not power on or (ii) repetitively reboot. Either situation would make the device inoperative, delaying therapy to a patient in need of defibrillation, cardioversion, pacing, or monitoring.</p>
<p>ACTION TO BE TAKEN BY CUSTOMER / USER – 1</p>	<p>When inspecting the device, inspect the HeartStart MRx battery compartment connections. Include this step as part of a routine Operational Check to verify that the battery connector pins are clean, fully extended, not bent, and without residue.</p> <p>Figure A: Battery Connector Pins</p>

<p>Battery Connector pins, eight in each compartment</p>

<p>ACTIONS PLANNED BY PHILIPS - 1</p>	<p>Philips is voluntarily initiating this correction and is providing an Instructions for Use (IFU) Addendum entitled, <u>HeartStart MRx Battery Connector Pins</u>, for all customers with affected units.</p>

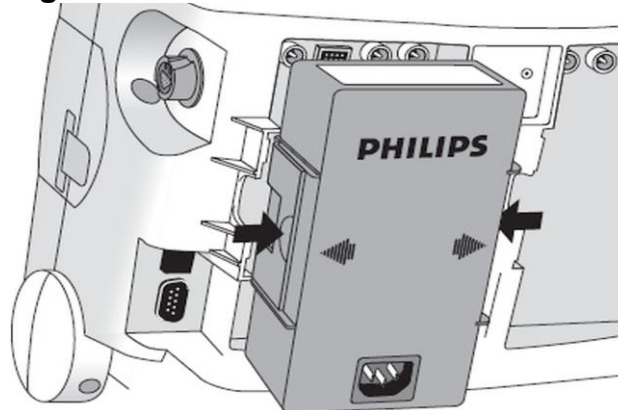
Figure C: AC Module Removal

- a. Remove the AC module from the MRx, rather than unplugging the cord from AC mains (see Figure C).

<p>b. Turn on the MRx using the rotary knob and allow it to complete the start-up before unplugging the device from AC mains.</p> <p>Philips also reminds you to keep batteries fully charged before use, as per the instructions in the HeartStart MRx Monitor/Defibrillator Instructions for Use (IFU).</p>
ACTIONS PLANNED BY PHILIPS - 2	<p>Philips is voluntarily initiating this correction and is providing measures to prevent, or methods to allow the user to correct, the abnormal device behavior related to charging and pacing after disconnecting the device from AC mains.</p> <p>Philips is evaluating both software and hardware changes to prevent this abnormal device behavior. Once the solution is available, you will be contacted by Philips if you have a device that is at risk of exhibiting this issue.</p>
FURTHER INFORMATION AND SUPPORT	<p>If you need further information or support concerning this notification, please contact your local Philips representative Please contact your Philips Representative or the UK Philips Customer Care Service Centre on 0870 532 9741.</p>
