Safety Advisory Notice

Safety Advisory Notice CT031/16/S

Re: SOMATOM Definition AS manufactured from May 2008 until December 2013 and SOMATOM Definition Flash manufactured from September 2009 until July 2012

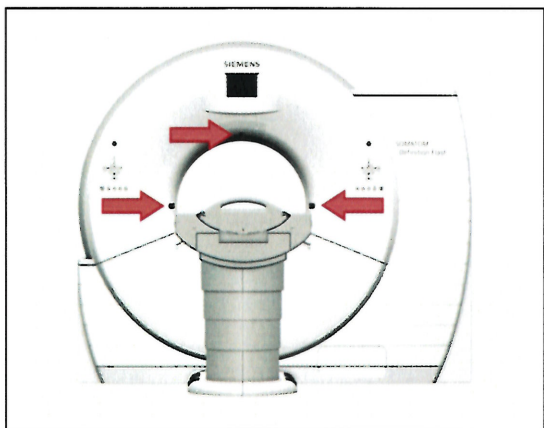
Fig. 1a: SOMATOM Definition Flash

We became aware, that in rare cases the small light marker window (see Fig. 1a and 1b) used for the positioning laser and integrated in the front cover of your CT could loosen and potentially drop out. In this case there is a risk that a person touches rotating or electrical parts of the gantry when reaching through the window opening. There is a risk for serious injury e.g. by electrical shock or physical harm to fingers.

As operator you should not use the CT system in case a light marker window is missing or loose. Please inform immediately the Siemens Service for correction.

Our experts will develop a solution for the correction of the problem as quickly as possible. As soon as we released the correction, we will inform you about the start of the measure and we will inform you when this correction has been successfully implemented.
