<b>autochair</b>	<b>FIELD SAFETY NOTICE</b>	FSN Doc No.	FSN-0001
		Issue Date	27/10/17

<b>Affected Product</b>	<b>SmartBase</b>
<b>Product Code</b>	<b>9934100</b>
Manufacture Dates	February 2012 to August 2017
Serial Numbers	All
<b>MHRA Reference</b>	<b>2017/008/015/601/007</b>
Autochair Reference	AC-FSN-001-MHRA
<b>Type of Action</b>	<b>Retrofit of Fail-safe Device</b>

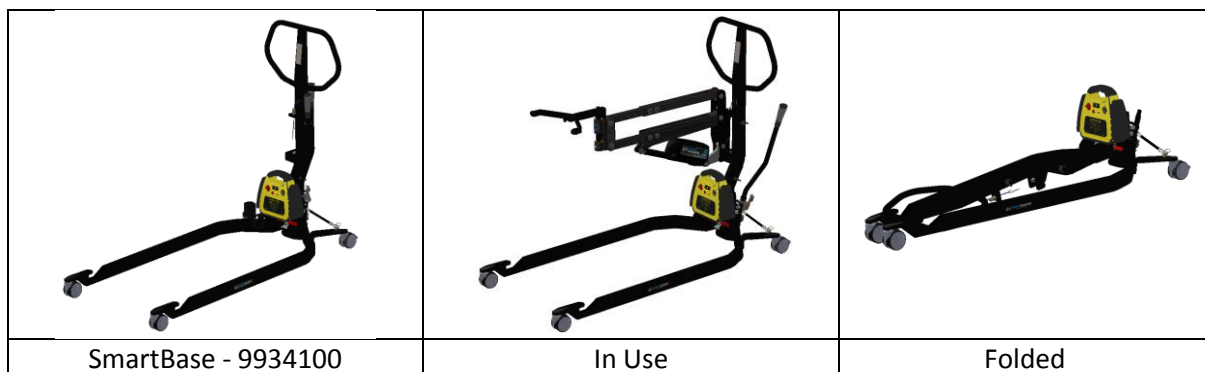
The SmartBase manufactured by Autochair Ltd is used in conjunction with the Milford Person Lift to provide a Person Lift solution. It is used to transfer users between a seat and a wheelchair and is for home use only. When not in use the device can be folded.

This FSN applies to all SmartBase units manufactured by Autochair Ltd.

The combination of a weak spring and incorrect alignment of the locking pin for latching the leg positions in the intended operating positions has led to the legs closing fully when a side load is applied to the legs. This has caused the legs to close fully to the stowed position, causing the device to become unstable and the patient to fall.

Although there have been no other related incidents reported for any of the devices already in use (632 units), Autochair has identified that this could also occur if the pin becomes worn, and it therefore represents a potential risk to all users of the device.

- Check the operation of the locking mechanism and, if there is any concern over the use of the device, remove it from service.
- Autochair Ltd will provide a Retrofit Fail-safe Kit which can easily be installed on all the SmartBase units.

- Upon receipt of the Retrofit Fail-safe Kit, follow the instructions provided to complete the install on the SmartBase.
- Check the Kit is fitted and operating correctly by following the checking procedure detailed in the instructions.
