Subject: **URGENT MEDICAL DEVICE REMOVAL NOTICE**

Affected Products:

ZFA 2016-119
--------------

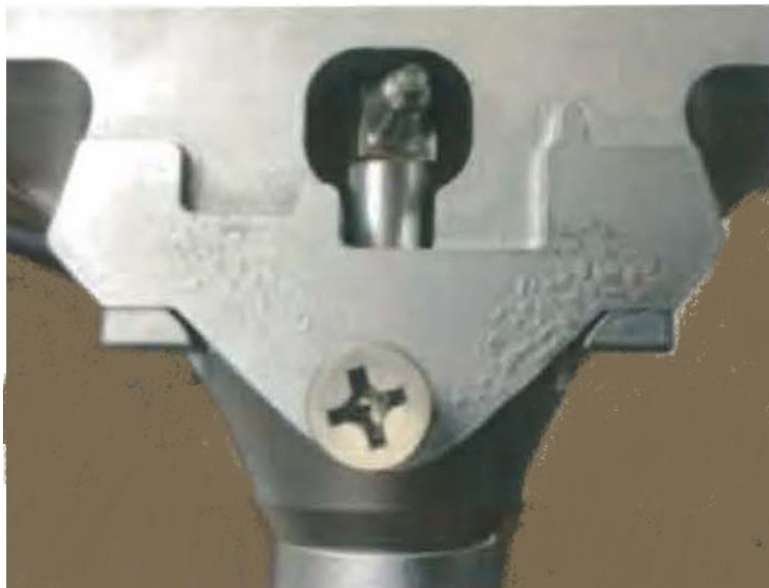
In follow-up to the July 13, 2016 recall correction notice, Zimmer Biomet Surgical is initiating phase II of the applicable voluntary recall of the Zimmer Air Dermatome II Handpieces and Zimmer Air Dermatome II Width Plates due to the potential for the surface coating applied to the device to blister, peel, and discolour after usage over time. Replacement Zimmer® Air Dermatomes are now available.

All serial numbers of the Zimmer Air Dermatome II Handpieces and all lot numbers of the Zimmer Air Dermatome II Width Plates, distributed between March 2012 and August 2015 (including loaner devices) are included in this removal. Zimmer Biomet Surgical received product complaints reporting that the surface coating applied to the device is blistering, peeling and discoloring after usage over time (see Image 1). There have been no injuries associated with the reported complaints. In addition, an independent assessment determined that the blistering, peeling and potentially flaking of the surface coating is not expected to result in any long range health consequences. Given that the frequency of this surface coating condition can worsen with age, these devices are being recalled to prevent future complaints.

Image 1. Blistering on Zimmer Air Dermatome II

Immediate health consequences (injuries or illness) that may result from use of or exposure to the device issue.	<b>Most Probable</b>	<b>Worst Case</b>
	Use of the device with the surface characteristics (blistering/peeling) could result in gray coating flakes on the skin graft and/or donor site, resulting in the opportunity for the operating team to see the gray coating flakes. In which case, copious irrigation with saline should remove the flakes easily from both skin graft and donor site.	Theoretically, coating flakes could contact both the harvested skin graft as well as the donor site. The coating composition contains nonvalent chromium that is not readily absorbed by the skin. If coating flakes were not detected and remain on the skin graft, the skin graft would not “take” in the areas where the flakes were present, resulting in small open wounds that would eventually close once the flakes were no longer present. Likewise, a donor site that had coating flakes adherent might not re-epithelialize in the usual 1-2 week timeframe focally where the flakes blocked keratinocyte proliferation. Eventually, either the flakes would be removed by an external agent or the patient’s body would eventually expel the flakes and the small focal wounds would eventually close on their own.

1. Review the notification and ensure affected personnel are aware of the contents.
2. **Locate and quarantine all affected product identified in table above.**
3. Carry out a physical count and sterilize all of the affected product in your hospital/clinic and complete Attachment 1 – Certificate of Acknowledgment and Sterilization (enclosed). Email a completed copy of Attachment 1 to [Fieldaction.Emea@zimmerbiomet.com](mailto:Fieldaction.Emea@zimmerbiomet.com).
4. Your Zimmer Biomet sales representative will remove the recalled product from your facility.
5. The model 8851 Zimmer® Air Dermatome II has been discontinued. Please contact your local Zimmer Biomet distributor or representative to order replacement devices.
6. **If after reviewing this notification you have further questions or concerns please contact your local Zimmer Biomet representative.**
