**AMENDED –  
URGENT FIELD SAFETY NOTICE**

GEHC Ref# 32067-A

RE: Giraffe Warmer/Panda iRes Warmer - Bedside panels or latch areas may be cracked, broken, or damaged.

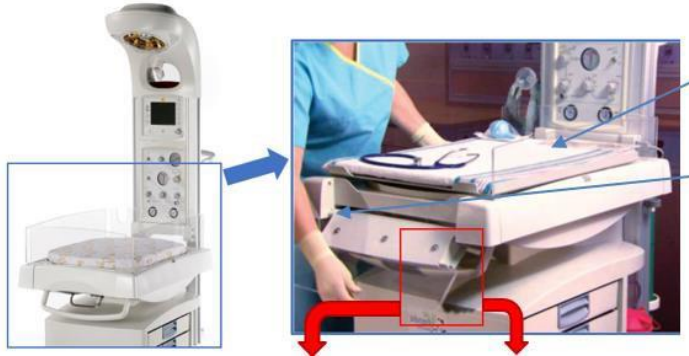
**BEFORE EACH USE OF THE DOOR PANEL:** Visually inspect for any cracks or damage to the beside panels, the latch area, and the area connecting the panel to the bed (see below Figure 1B). If any portion of the bedside panels or latches is damaged or cracked (see below Figure 1C), **stop use of the warmer.**

Figure 1A: Bedside panels

Figure 1B: Area connecting panel to bed

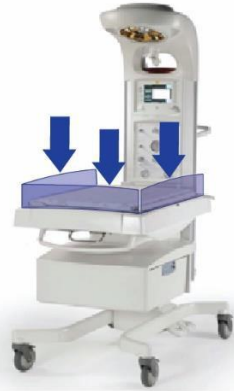
Each warmer has 4 bedside panels. Do the procedure listed below for each of the 3 movable bedside panels. One label must be applied to each bedside panel.

**Note:** A Panda warmer is shown above. Giraffe iRes warmers have higher bedside panels, but the labels are applied in the same locations, as shown by the blue arrows above and specified below.

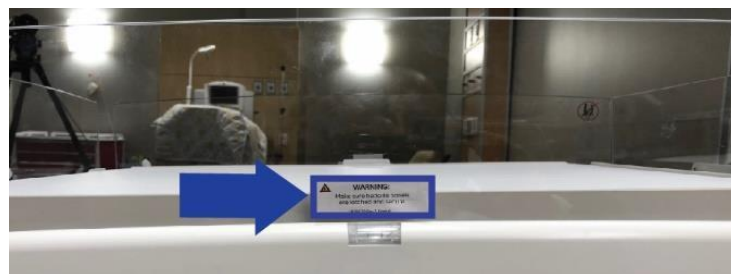
**Side bedside panels:** Attach the label .25 inches (6 mm) above the level window at the bottom of both side panels.

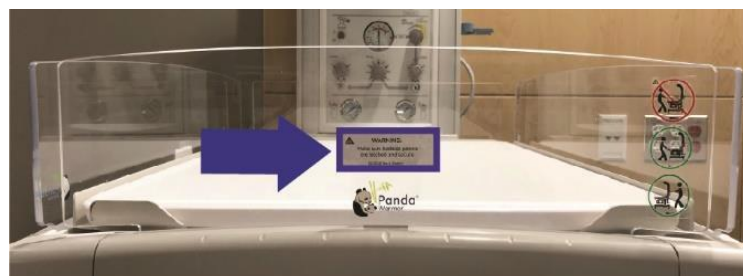
**End bedside panel:** Attach the label 0.25 inches (6 mm) above the logo sticker.
