Axminster Respiration Monitor Service Update 010608

Action Required

SERIAL NUMBERS 001360 to 001660

Baby Sleepsafe
Monitor Model AE 010 M

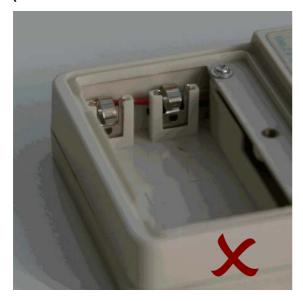
It has been brought to our attention that if the monitor is subjected to physical impact the battery terminals can become loose. We recommend that the condition of the battery terminals be regularly inspected.

Replace terminals of this type.

At least every 12 months inspect the battery terminals for signs of corrosion and ensure they are applying firm pressure to the batteries. Replace corroded or deformed battery terminals.

If your monitor(s) have serial number(s) between 001360 and 001660 and are not already fitted with coil spring battery terminals you may return the monitor(s) for upgrade. Please return to: -

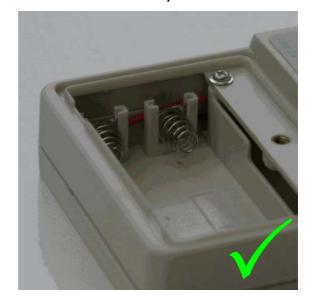
The problem has since been prevented with a spring coil battery terminal on monitors serial number 001660 to 001950 and by using our original battery terminal from 001951 to date. We recommend that if the monitor has a serial number between 001360 and 001660 and is not fitted with coil spring battery terminals that they are returned for upgrading. Serial numbers below 001360 use a flat spring made from a more resilient material which we have not experienced problems with, this has been used again from serial number 001951 to date.

Coil Spring terminal fitted.
