Ceiling hoist Product-information/change GH3 Trolley

Product-information No. 01-417
Skejby, Date 13.02.2012

GH3 Trolley guide No. 550097

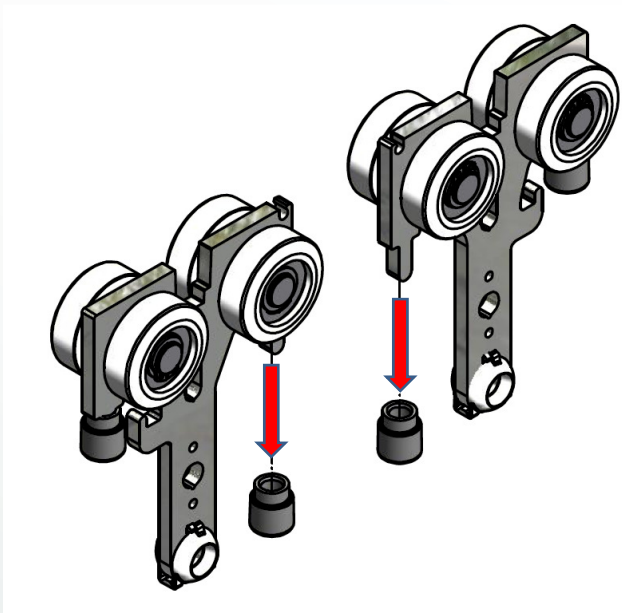
In order to secure an optimal closing of the Combi-lock gate it is important to remove the inner guide bush on all GH3 and GH1 trolley sets.

Implemented in production from January 26, 2012

REMEMBER: Guide bush should be removed on all hoists during the next inspection or service

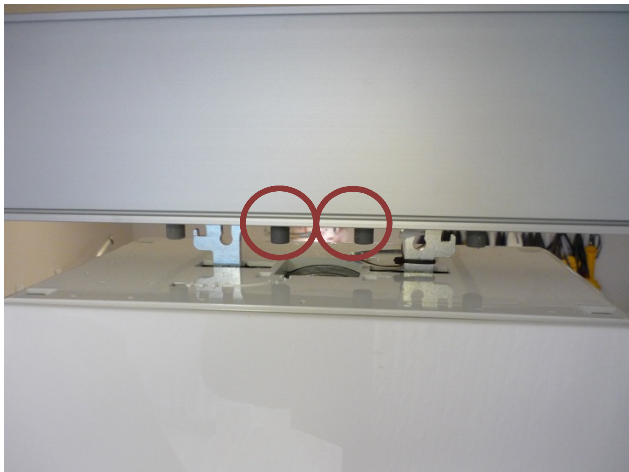
1)

Instruction for removing the trolley guides on GH1/GH3

Use a piece of paper to insert between the two trolleys to prevent the trolley guides from falling into the hoist when you remove the two inner trolley guides.
