URGENT FIELD SAFETY NOTICE

GEHC Ref# 36132

RE: B20/B20i/B40/B40i (Bx0), and B105/B125 (B1x5) patient monitors may restart due to network overload situation caused by network misconfiguration

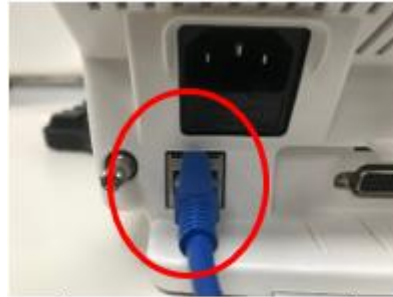
B20/B20i/B40/B40i

- Disconnect the Ethernet (LAN) cable from the port* on the back of the monitor (see below pictures for location). The monitor will now be in local-only mode.
- Keep the patient under close observation and continuous surveillance at the local (bedside) monitor

The exact configuration of your monitor(s) may vary slightly from the photos above, but the Ethernet (LAN) port will be in the same position.

2. Contact your IT department or other appropriate personnel in your facility responsible for the Patient Monitoring Network and provide them with the additional instructions on network configuration provided in Appendix A below.
3. After the network issue has been resolved, switch the monitor back into central monitoring by re-connecting the Ethernet (LAN) cable to the appropriate port (see above pictures for location).
4. Verify correct monitoring state and alarm function.
