Urgent Field Safety Notice

Our Ref: 4215 FSCA, VITEK 2 - Card Pouch Integrity

VITEK® 2 Identification (ID) / Antimicrobial Susceptibility Test (AST) Cards referenced in Appendix A.

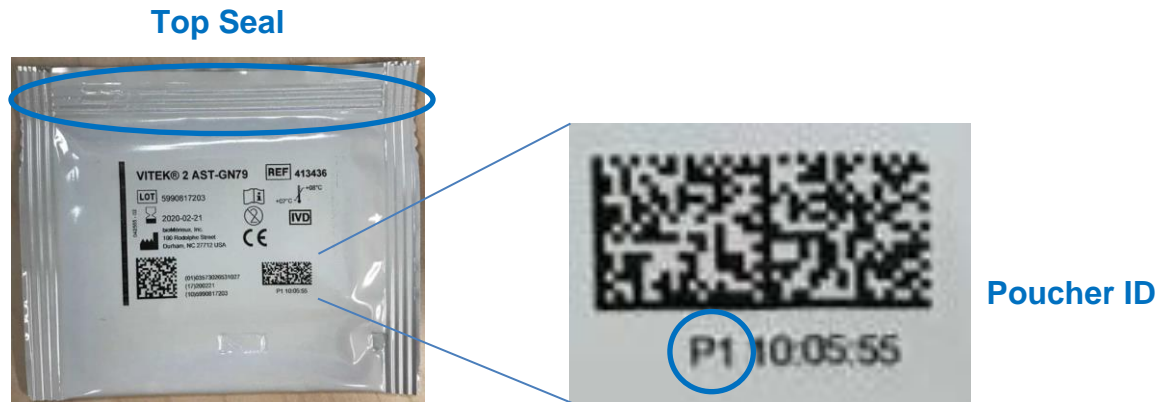
Figure 1: Top Seal and Pouch ID

A potential issue was identified related to the top seal of card pouches containing the VITEK® 2 test cards for the product lots specified in Appendix A. bioMérieux has determined that the integrity of some of the VITEK® 2 test card top seal may be compromised (see Figure 1). Based on our investigation, a compromised test card top seal can impact card reagents due to the entry of moisture.

bioMérieux investigation concluded that the pouch top seal of the card lots manufactured on a specific card poucher (Pouch 1) between 10Aug2018 and 29Aug2018 is potentially compromised. A small section of the top seal may be improperly sealed for the card lots indicated in Appendix A.

1. As VITEK® 2 ID/AST cards may be pouched on different pouching equipment in manufacturing, confirm the card was pouched on Pouch P1 and determine if a P1 indication is present (Figure 1). Cards that have other identifiers, such as P2, P3, etc. are not impacted.
2. Grasp the card pouch so the top seam is facing you.
3. Apply a modest pulling force to each side of the top edge of the pouch, at three (3) separate points as shown in the images below.
