URGENT FIELD SAFETY NOTICE

Product Name: **Alaris® SmartSite® Needle-Free Valve**
Product Reference: **2000E7D**
Lot Numbers: **Various lots with Polycarbonate Material**
FSCA Identifier: **RA-2014-01-01**
Date: **February 2014**
Type of Action: **Removal & Destruction of Affected Products**

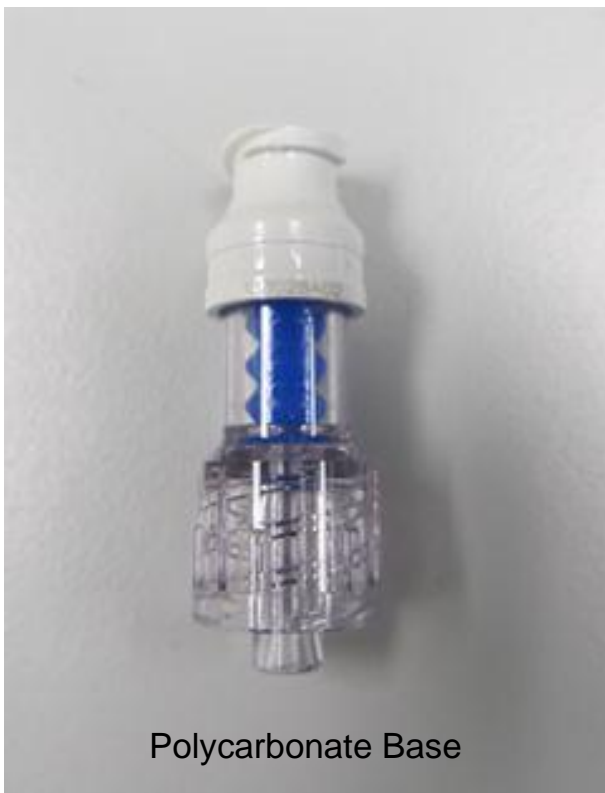
Polycarbonate Base

CareFusion has identified a potential risk with various lot numbers of the Alaris® SmartSite® Needle-Free Valve - 2000E7D made with Polycarbonate. The affected SmartSite connector lots may unintentionally disconnect from a female Luer, may be difficult to disconnect from a female Luer, or may fail to disconnect from a female Luer once attached. In rare occasions limited leakage may also be observed if the connector disconnects from the female Luer during infusion. An inability to disconnect may require replacement of a central or PICC line or catheter.

The root cause is still under investigation. Preliminary analysis has indicated that SmartSite with polycarbonate material may cause incompatibility issues with the male Luer or thread housing when attaching to a female Luer.

SmartSite with acrylic material does not appear to cause these incompatibility issues and is not affected by this FSCA. There is a visible colour difference between the polycarbonate and acrylic base. The polycarbonate material is bluish-grey whilst the acrylic material is clear. As shown in the pictures below.

In order that the potentially affected products are removed from use and destroyed please follow instructions below:

Step	Action	
1	Inspect inventory for product affected lot numbers of 2000E7D. (listed in Appendix 1)	
	If...	Then...
	No affected lot numbers are found	<ul style="list-style-type: none"> Complete sections A & B of Appendix 1
	Affected lot numbers are found	<ul style="list-style-type: none"> Complete sections A & C of Appendix 1 Destroy affected product according to hospital protocol
2	Return completed verification form (Appendix 1) to your CareFusion representative no later than 31 May 2014	
3	Please contact your local CareFusion representative to order alternative products.
