DATE: **April 15th, 2022**
FSCA Ref: **FARS-006**

Urgent Field Safety Notice (FSN)
ook snow ALL

Risk of Collision due to Uninterrupted Motion of the Motorized Wheel System

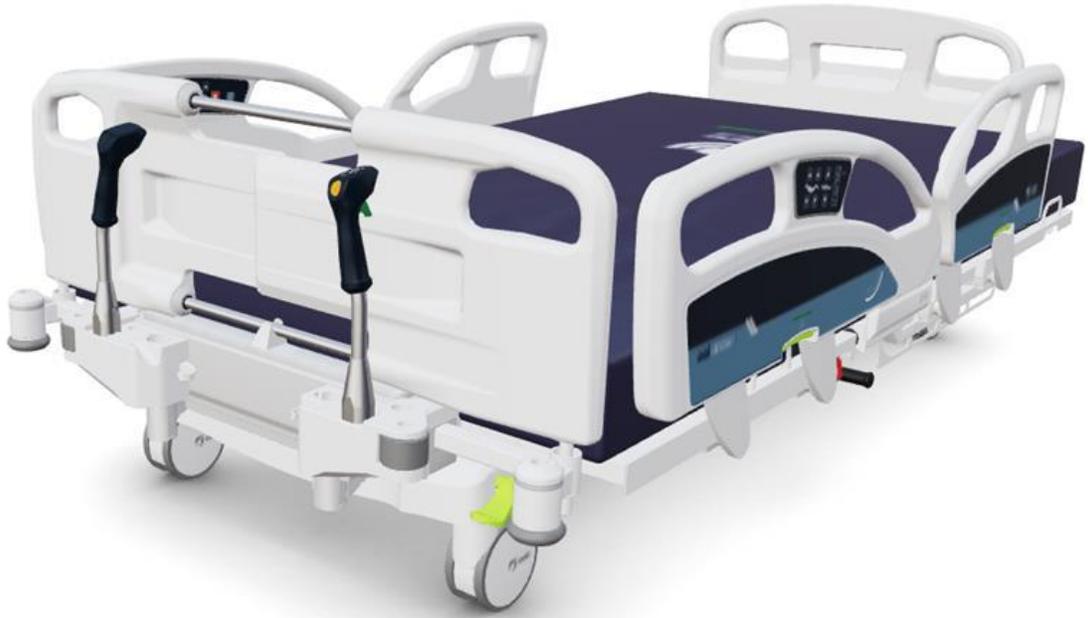
1. Information on Affected Devices*	
1	1. Device Type(s)*
.	Powered medical bed with a powered drive system (the “Motorized Wheel System”) bearing the option number OL2000200WG.
