**URGENT Field Safety Notice**

**Patient Information Center (PIC) iX Uninterruptable Power Supply (UPS) Failures**

**Reference:** CR # 2024-CC-HPM-010, PIC iX Uninterruptable Power Supply (UPS) Failures

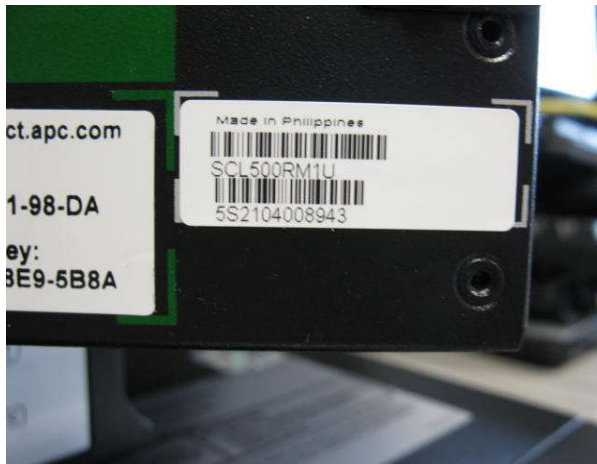
#### Image 1:

\* Affected APC UPS units were manufactured during a specific time frame. For ease in determining a unit status, individual unit serial numbers contain a number sequence to identify the year and week (YYWW) of manufacture. Using the example from Image 1 below, the unit serial number is 5S2104008943, meaning it was manufactured during week 04 of the year 2021. The serial number format is 5SYYWW123456.

Manufacturer Part Number is SCL500RM1U, with Serial Number 5S2104008943 on the UPS device.  
Week 04 of 2021
