# Field Safety Notice: RA2024-3589151

**Product Field Action #:** RA2024-3589151

**Product Name:** EXETER 2.5 IM PLUG

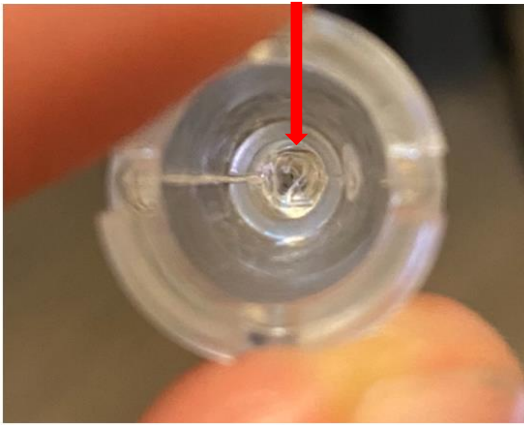
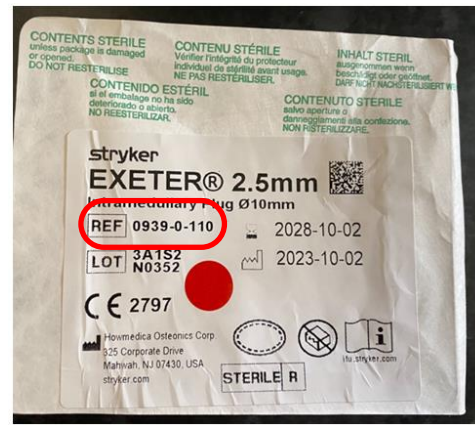
**Figure 1:**

Stryker has discovered the potential that the size on the package label of the EXETER 2.5 I M PLUG may not match the device within the packaging (Figure 1 below).

Images showing part marking for 12mm Exeter IM Plug found in package labelled for 10mm Exeter IM Plug

1. Circulate this Field Safety Notice internally to all interested/affected parties.
2. Maintain awareness of this notice internally until all required actions have been completed within your facility.
3. Segregate all of the recalled devices identified in the affected product list (see *Table 1, page 1*) and

notify your Stryker Representative of the identified inventory. Discard/dispose of the recalled device(s) following your appropriate internal process.
