With this procedure potentially affected Sample Probes can be identified both already installed Sample Probes and still boxed Sample Probes.

Identification of potentially affected sample probes for cobas c501/ cobas c502 and cobas c311

Identification of potentially affected sample probes for cobas c701/ cobas c702

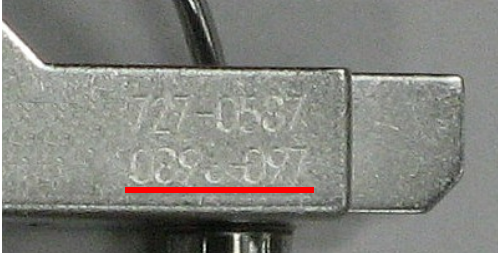
</div> <p>Either NAKA or OMUTA is indicated on the original package. Either Black or Green dot is marked on the sample probe.</p> <p>Black dot: Produced by NAKA Green dot: Produced by OMUTA</p>
Printed place on sample probe	<div style="display: flex; justify-content: space-around;">

</div> <p>Refer to Rule of printed serial number for detail.</p>

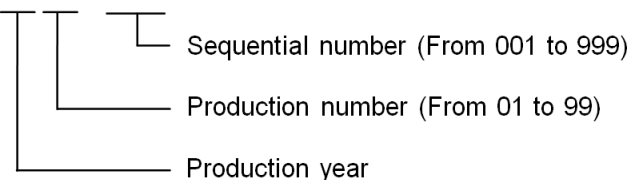
<p>Rule of printed serial number</p>	<p>727-0587 ← Part number YY AA – BBB ← Serial number</p>

<p>Sequential number (From 001 to 999) Production number (From 01 to 99) Production year</p> <p>Serial number printed on the probes for cobas c501/c502 and cobas c311 are making a common numbering by HHT's two production lines.</p>
<p>Place of yellow dot on the connector</p>

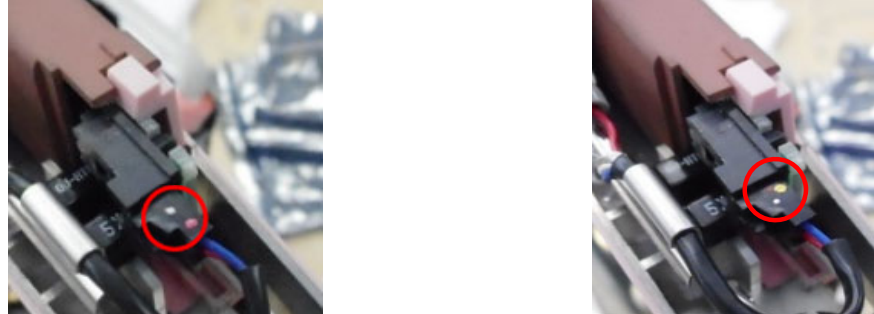
<p><u>No yellow dot mark</u> on the connector is affected. If the yellow mark on the connector is existed, the probe was modified done by HHT despite if the Serial number which printed on the probe was met.</p>
<p>SAP lot number which printed on the original package</p>

There are two HHT production plants NAKA & OMUTA producing Sample Probes. Potentially affected Sample Probes can be easily encountered by the following procedure. If a yellow dot is applied to the Sample Probe connector the Sample Probe is already equipped with a modified connector.

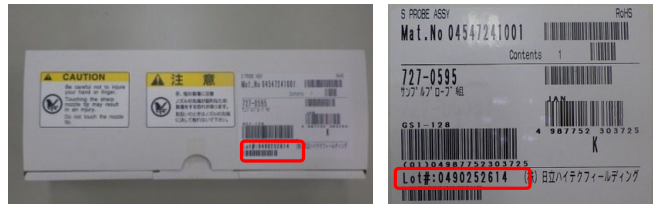
<p>Affected Sample Probe for cobas c311 (P/N 724-0920)</p>	<p>Lot number which indicated on the logistics label 0490232027, 0490233855, 0490236427, 0490238543, 0490241937, 0490248322, 0490250880, 0490235713, 0490252029, 0490256963 (not affected), 0490254335 (new)</p>

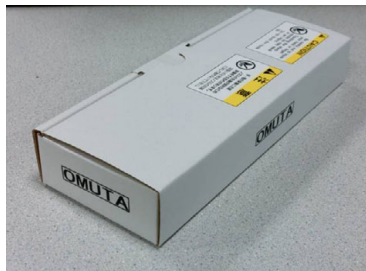
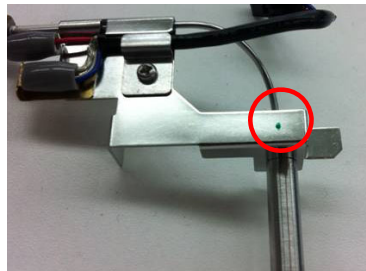
</div> <p>Either NAKA or OMUTA is indicated on the original package. Either Black or Green dot is marked on the sample probe.</p> <p>Black dot : Produced by NAKA Green dot : Produced by OMUTA</p>
<p>Place of yellow dot on the connector</p>	<div style="display: flex; justify-content: space-around;">

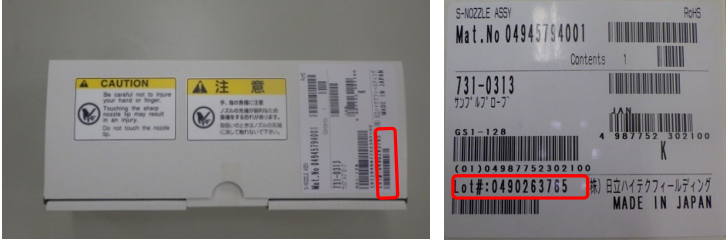
<p>SAP lot number which printed on the original package</p>

<p>Refer to the separate attachment for detail of SAP lot numbers which printed on the original package.</p>
<p>Affected Sample Probe for cobas c701/cobas c702 (P/N 731-0313)</p>	<p>0490238960, 0490238961, 0490238961, 0490238961, 0490238963, 0490242332, 0490251040, 0490251041, 0490252546, 0490252547, 0490252547, 0490254810, 0490254811, 0490221658, 0490223228, 0490223229, 0490225255, 0490226172, 0490226173, 0490226174, 0490227626, 0490227627, 0490227628, 0490230276, 0490230277, 0490230279, 0490232203, 0490232204, 0490232205, 0490232206, 0490233778, 0490233779, 0490233780, 0490233781, 0490233783, 0490235909, 0490235910, 0490235911, 0490235912, 0490235913, 0490237365, 0490237366, 0490237367, 0490237368, 0490237369, 0490237370, 0490238901, 0490238902, 0490238903, 0490238904, 0490242160, 0490242161, 0490242163, 0490242165, 0490242166, 0490250498, 0490250499, 0490250500, 0490250501, 0490250502, 0490252308, 0490252312, 0490252318, 0490252320, 0490252322, 0490254558, 0490254559, 0490254560, 0490254561, 0490254562, 0490257035, 0490257036, 0490257037, 0490257038, 0490257039, 0490257854, 0490257855, 0490257856, 0490257857, 0490257858</p>
