URGENT FIELD SAFETY NOTICE / MAGEC® SYSTEM

COMMERCIAL NAME: **MAGEC® System**

TYPE OF ACTION: Advisory Notice

MAGEC® System manufactured prior to March 26, 2015

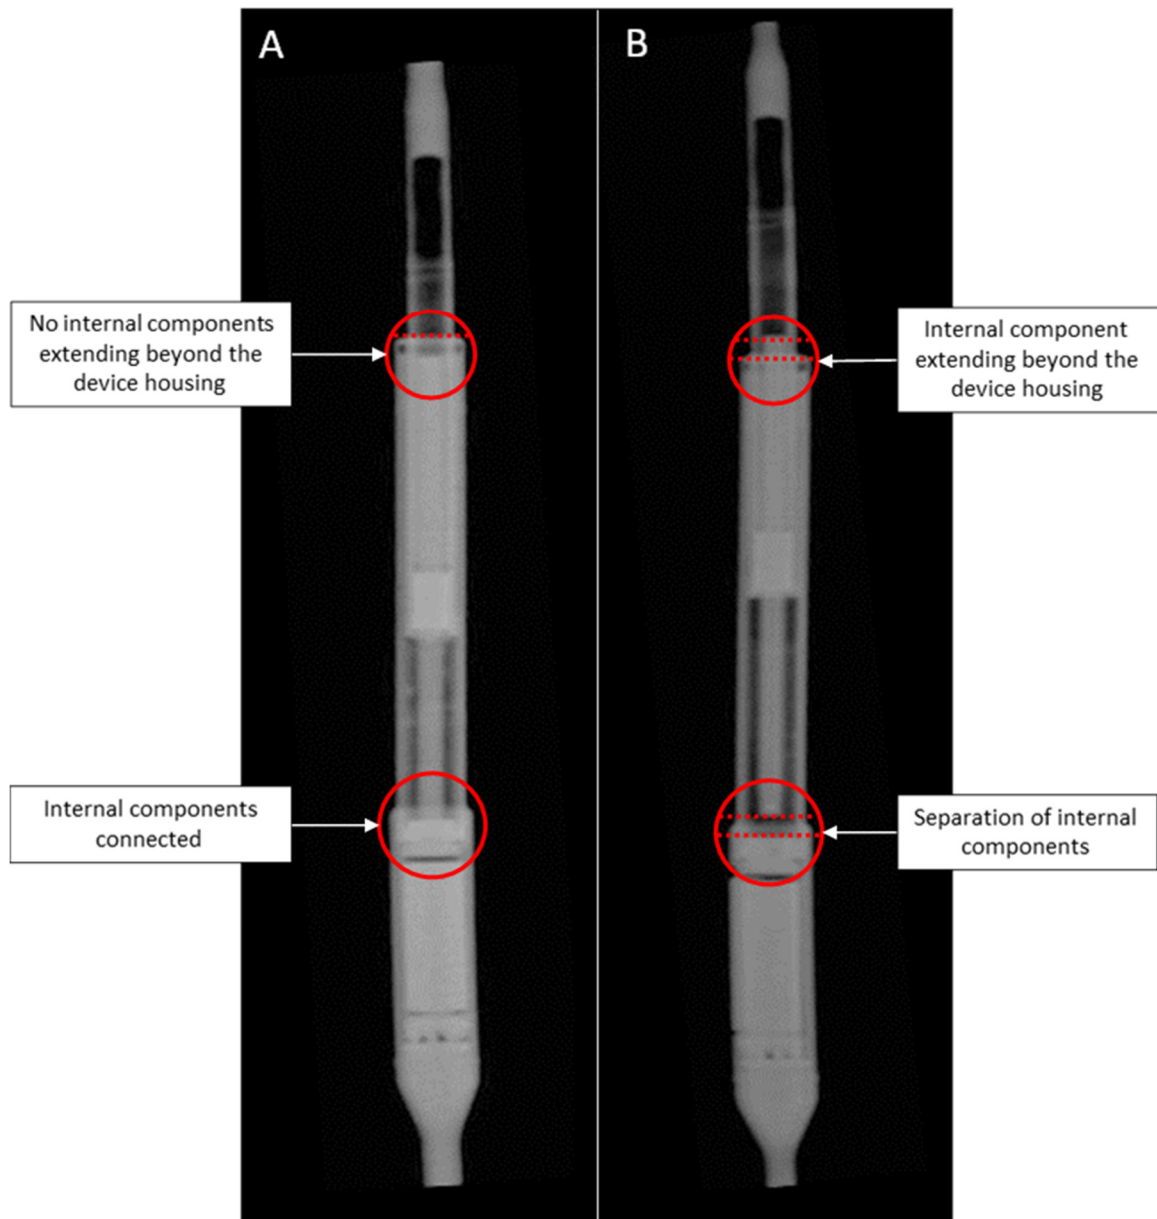
Figure 1: Representative X-ray images of a device with an intact locking pin (A) and a device manufactured prior to March 26, 2015 with a fractured locking pin (B). Visual Identifiers of a fractured locking pin can include separation of internal components and the extension of an internal component beyond the device housing.

- The IFU should be consulted on an ongoing basis throughout patient treatment with the MAGEC® System.
- Users should follow the appropriate postoperative procedure to assess the MAGEC® System by X-ray imaging whenever the device is adjusted or at a minimum of once every six months. Typically, the device can be adequately visualized, and a fractured locking pin can be detected, on standard anteroposterior X-ray imaging. Figure 1 shows representative X-ray images for comparison of a device with an intact locking pin (A) to a device manufactured prior to March 26, 2015 with a fractured locking pin (B). A fractured locking pin can typically be identified by examining the noted areas to detect the separation of the internal components and/or the extension of an internal component beyond the device housing.

- If a fractured locking pin is detected, removal of the device may be indicated. The decision to remove the device should be made by the physician in consultation with the patient and/or family.
- If removal is deemed appropriate by the physician, the device and all associated accessories should be removed and the explanted device should be returned to NuVasive.
- Clinical users should review the IFU and be aware of the warnings and precautions on an ongoing basis throughout patient treatment with the device.
- Patients and/or families should be reminded of the importance of following the postoperative care instructions in the IFU.

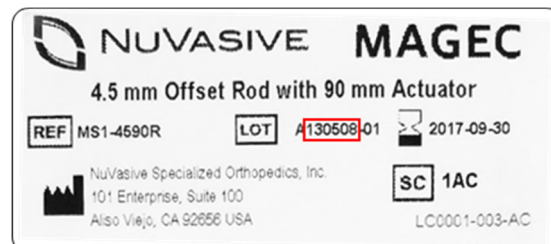
Figure 2: Representative patient chart label showing device lot number. The 6-digit numerical string (e.g. 130508) is indicated by the red box.

- To determine the date of manufacture, identify the 6-digit numerical string within the lot number. The device lot number is provided on the label and/or recorded in the patient record. A representative patient chart label is shown in Figure 2.

- If the 6-digit string (indicated by the red box in Figure 2) is numerically less than the 150326, then the device was manufactured prior to March 26, 2015.
- If the 6-digit numerical string is greater than or equal to 150326, or the lot number format is different than the format shown in Figure 2, then the device was manufactured after March 26, 2015.
