URGENT Field Safety Notice

M5071A (adult) and M5072A (infant/child) pads for use with HS1/OnSite/Home AEDs may experience gel separation and reduction of gel surface area

21-FEB-2022

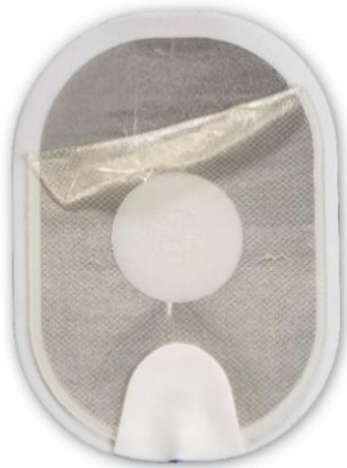
When a pad with separated, folded gel is placed on the patient's bare skin, the HS1/OnSite/Home AED could deliver less effective or ineffective therapy to the patient due to the reduced surface contact area with the skin. See example picture in **Figure 1**.

Figure 1: Separated gel that has folded onto itself when peeled.

Action:
Apply pads to the patient.
Do not hesitate.

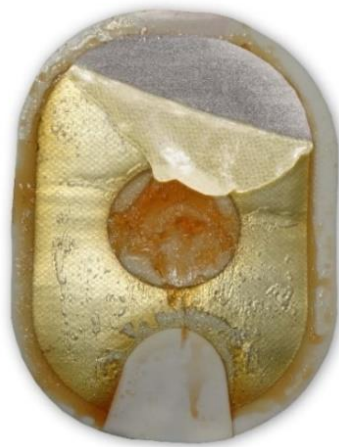
Separated, folded gel may also have a discolored and/or melted appearance. While the gel may also have a discolored and/or melted appearance, the appearance does not have any impact on the delivery of therapy; however, there may be a delay in therapy if the user hesitates to apply the pad due to its appearance, and the AED may deliver less effective or ineffective therapy to the patient due to the reduced contact area with the skin. See example picture in **Figure 2**.

Figure 2: Separated, folded gel may also have a discolored and/or melted appearance.

Action:
Apply pads to the patient.
Do not hesitate.

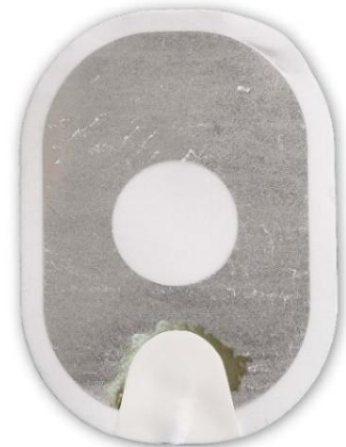
It is also possible that the gel could separate almost completely from the foam/tin backing when peeled, (see **Figure 3**.) Due to a small amount of gel surface contact area with the skin, electrical arcing could occur when a shock is delivered leading to burns to the patient's skin, or the AED could be unable to deliver any shock through the pads. A delay in therapy will result while the user installs a replacement pads cartridge (if available) or performs CPR while waiting for Emergency Medical Services Personnel to arrive. For comparison, **Figure 4** shows a normal pad. No matter the state of the pad, follow the voice prompts because the AED will step you through the necessary actions.

Figure 3: Gel almost completely separated from backing.

Action:
Replace pads cartridge if a spare is available. If no spare is available, perform CPR until help arrives.

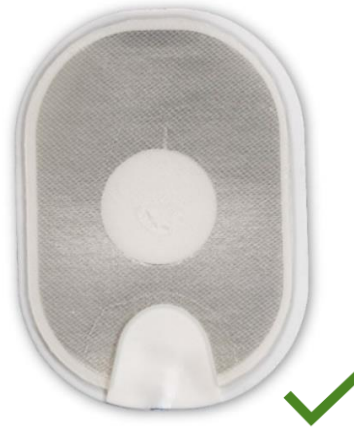
Figure 4: Normal pad.

Action:

Apply pads to the patient according to the Instructions for Use/Owner's Manual.
