URGENT Field Safety Notification

Tempus Pro Monitor
Unexpected Device Error When Used With Tempus Pro Video Laryngoscope

06-NOV-2023

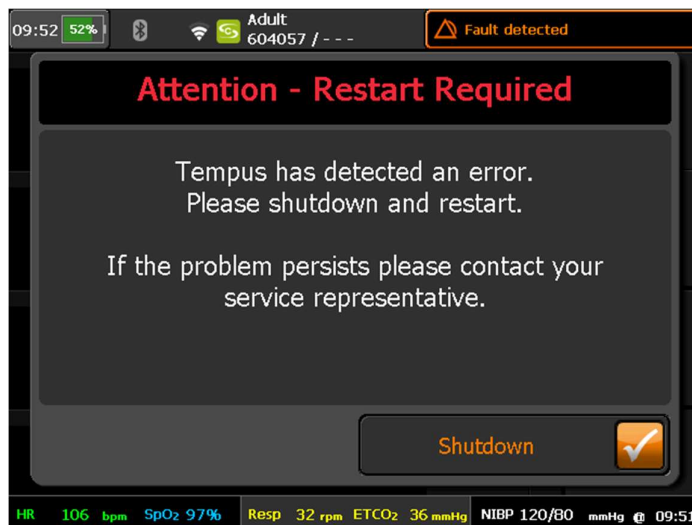
An issue has been identified with the Tempus Pro Monitor where an error may occur during video laryngoscope use with the Tempus Pro Video Laryngoscope or immediately after the Tempus Pro Video Laryngoscope has been unplugged from the Tempus Pro Monitor. If this error occurs, the user is presented with an unexpected full screen message informing the user an error has occurred, requiring shutdown and restart of the Tempus Pro Monitor. This full screen message prevents the user from viewing any graphical representation of patient vital signs; however, text and numerical values are still visible on the device's display screen. A visual of the message is shown below:

If this error occurs, the patient pulse tone (audio) that reflects the patient's level of oxygen saturation is no longer sounded and there will be no additional patient or device alarm LEDs or audio alarms while the error message is displayed. Additionally, the user will no longer be able to visualize the airway requiring the user to either intubate the patient without video imaging or use an alternative

laryngoscope not connected to the Tempus Pro Monitor. This message cannot be cleared from the Tempus Pro Monitor's screen and most of the monitoring functions are not available until the user initiates a complete shut down and restart of the device, which may take 60-100 seconds.

- When you receive the updated software solution from Philips, please install the software (V07.34) on your Tempus Pro Monitor according to the installation instructions provided. Once updated, you may resume use of the Tempus Pro Video Laryngoscope if you had removed it from service.

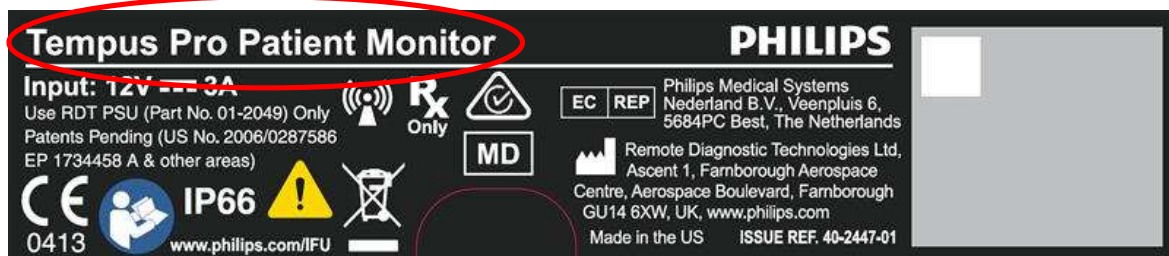
This correction directly affects Tempus Pro Monitors with Part Numbers 00-1004-R, 00-1007-R, 00-1024-R, and 00-1026-R with Trizeps-7 hardware, software v07.26 through v07.30, while using the Tempus Pro Video Laryngoscope with Part Number 01-2044. While Tempus Pro Monitors with Part Numbers 00-1004 and 00-1007 are not directly affected, these devices may have their hardware updated to Trizeps-7 hardware so are being included in this correction as a precaution. Tempus Pro Monitors are identified by a label placed on the rear of the device. An example is shown below:

The product number (REF) and Serial Number (SN) are printed in the gray box.

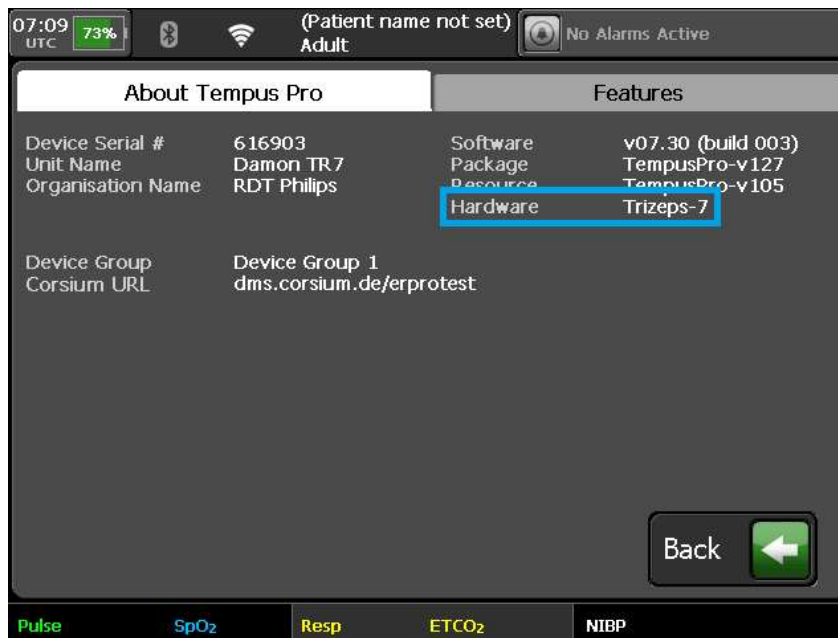
- Check the 'About Tempus Pro' screen on the Tempus Pro monitor(s) to determine which Hardware version is present by following these steps:

4. Identify the Hardware Version (Trizeps-7 or Trizeps-6)

- If the Tempus Pro Monitor has **Trizeps-7** Hardware, remove the Tempus Pro Video Laryngoscope from service with this monitor. Users must use an alternative laryngoscope not connected to the Tempus Pro Monitor to manage the patient's airway to avoid interruption in patient care. The Tempus Pro Monitor can remain in service if the Tempus Pro Video Laryngoscope is not connected to the monitor.

- If the Tempus Pro Monitor has **Trizeps-6** Hardware, the Tempus Pro Video Laryngoscope can continue to be used with the monitor.
- Post this Urgent Field Safety Notification letter on or near your Tempus Pro device.
