Subject: URGENT - FIELD SAFETY NOTICE – INTEGRA – CUSA® Excel 23KHz Straight Handpiece – Reference: C2600 – FIELD SAFETY ACTION

Legal manufacturer: Integra Lifesciences, IDA Business and Technology Park, Sragh Ave, Tullamore, Co. Offaly – IRELAND. IE-MF-000003849

C2600

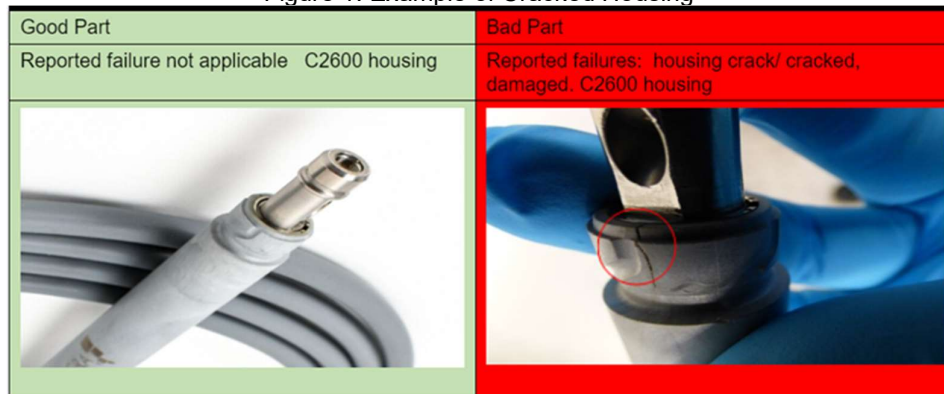
Figure 1: Example of Cracked Housing

The decision to conduct a voluntary correction of the product was based on the following: through an internal investigation of customer complaints, it was identified that there is a potential for the CUSA Excel 23KHz Handpiece housing to crack. In order to mitigate this issue, the devices will be reworked through our service and repair process for the units manufactured prior to November 2023.

1. Inspect the housing for the presence of a crack – see image below.

2. The Handpiece cracked housing may be visually detected by clinical staff during inspections prior to or post-surgery. If a crack is noted, please remove the handpiece and return it for a free housing replacement.

7. The handpiece(s) should be returned to Integra S&R for service, email: TCS.Distributors@integralife.com, and there will be free replacement of the handpiece housing.

3. If a crack is not noted, Regardless of the service contract status, the housing will be replaced free of charge during your next service.
